History of Recent AAR Cases in Building Foundations in the Recife Metropolitan Area

T. ANDRADE ^a

^aMSc, Federal University of Pernambuco (UFPE) Department of Engineering

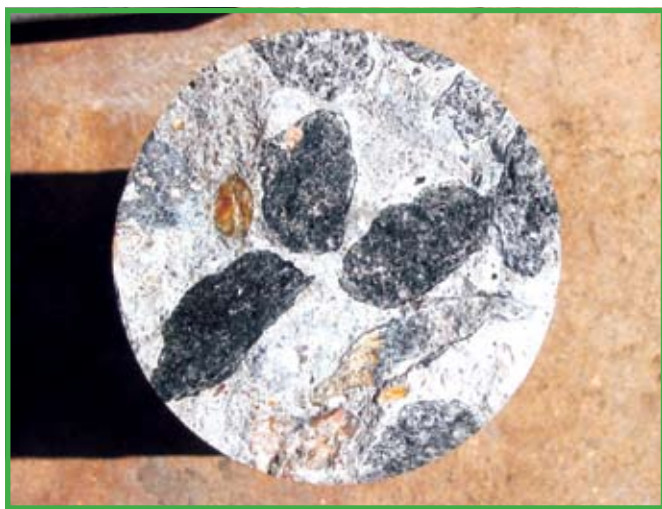
Figure 1 - Cracked side of the core

Cores were extracted for tests of the concrete's compressive strength and to measure the depth of the existing cracks. After the removal of the cores, visual observation of the cracked side of the specimens (top) indicated the existence of reaction rims between the coarse aggregates and the cement paste and that the concrete macropores were filled with a whitish gel, as can be seen in figures 1 and 2.

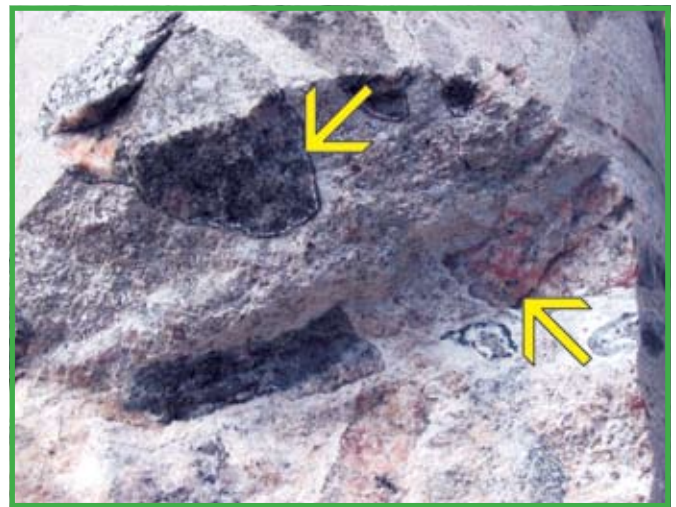
Figure 2 - Reaction rims seen surrounding the coarse aggregate

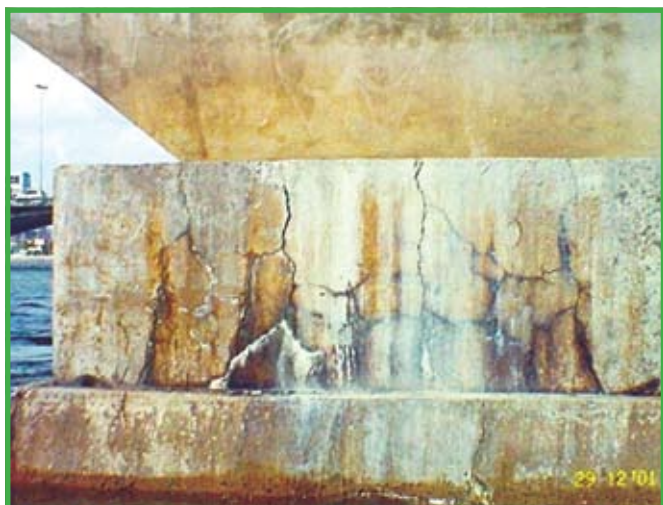
Built in 1977 and connecting Recife's inner city neighborhoods to the Boa Viagem neighborhood, that bridge had for several years featured intense cracking in the 16 foundation blocks, which remain partially submerged due to tide variations (fig. 03). In 2001, the Municipality of the City of Recife hired a company specialized in concrete technology to diagnose the causes behind the deterioration of the blocks.

Through investigations that included several tests on the cores extracted from the blocks – petrographic tests among them – an intense situation of alkali-aggregate reaction was verified.

Figure 3 - Fissures and crackings that are typical of expansion induced by the alkali-aggregate reaction in one of the blocks of the Paulo Guerra Bridge

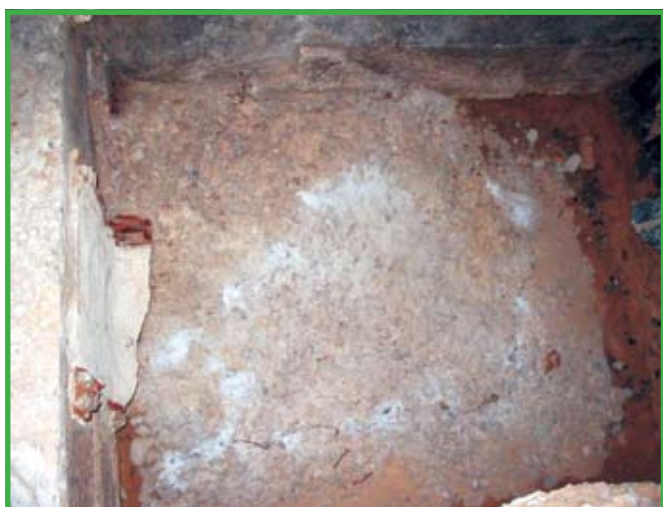
In the first case (the building close to the Areia Branca), seen in figure 1, a sample of the concrete was sent to the laboratory of the Brazilian Association of Portland Cement (ABCP) in São Paulo. Through the ASTM C 856 [01] and the NBR 7389 [2] test methods, the existence of the reaction between the aggregate and the cement past was verified.

In that analysis, the coarse aggregate was characterized as cataclystic gneiss, featuring strained quartz grains, with undulatory extinction and recrystallized microcrystalline quartz, which are features that may confer a reactive character on the aggregate.

Figure 4 - Concentric cracking in one of the base plates in the building close to the Areia Branca Building, where the holes bored for epoxy injecting can be seen

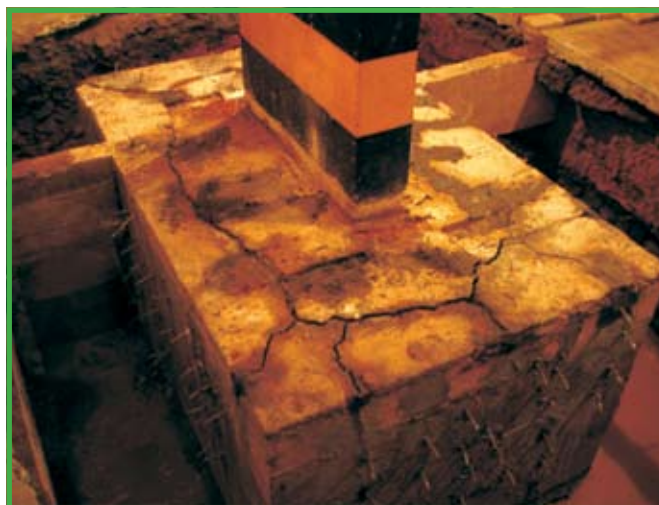
Figure 5 - Foundation block with top surface seriously cracked, featuring openings of up to 25 mm in some areas

Immediately after the first case, two new cases under suspicion emerged in a short time span. The second case occurred in a nine-year old, 24-storey building in the Boa Viagem neighborhood. Excavations down to the foundation blocks were prompted by the appearance of vertical cracking in one of the pillars in the garage level, and in cracking on masonry works located above the foundation blocks (figures 05 and 06).

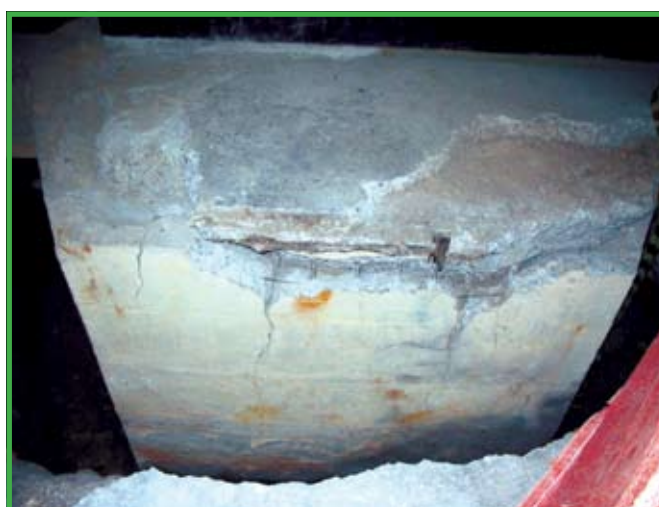
Figure 6 - Foundation block where cracking was first detected due to the appearance of vertical cracks that led to the excavation down to the foundation block

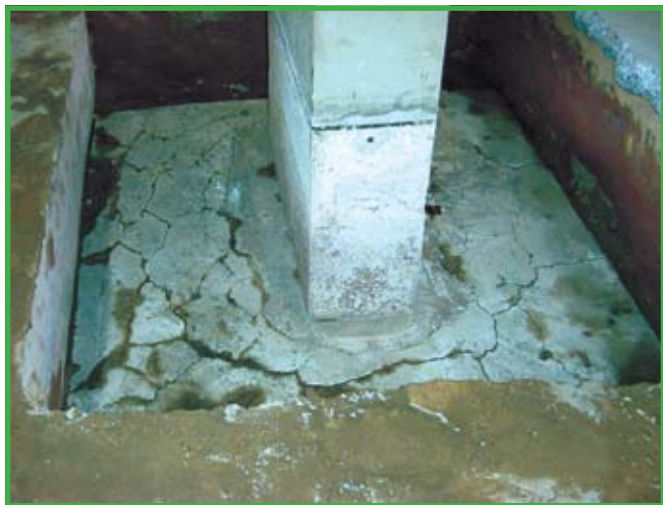
Figure 7 - Intense cracking on one of the foundation blocks in the downtown commercial building

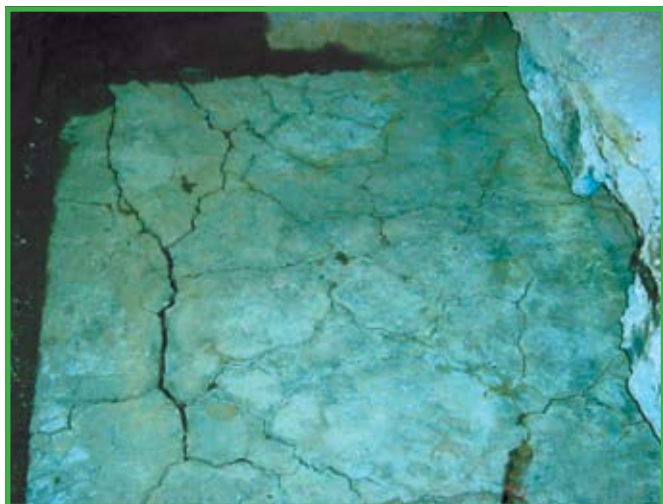
Figure 8 - Detail of crack on the left side of another block, with an opening of more than 30mm

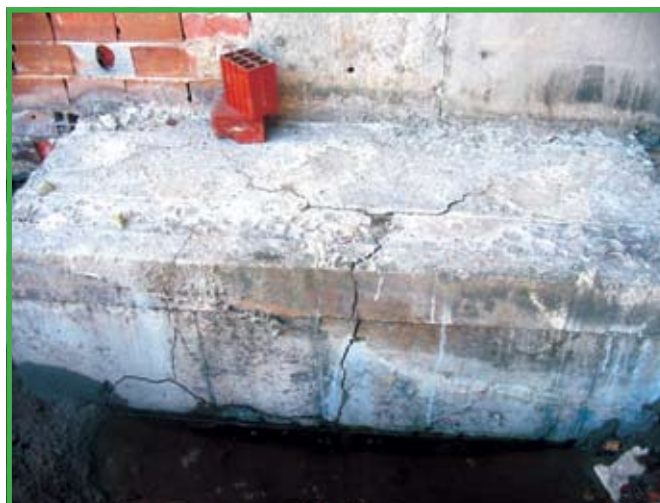
The fifth case occurred in the Piedade neighborhood, in the RMA, in two 11-year old buildings of the same constructors. Inspection of these buildings was not stringent, and some blocks appeared severely cracked (photos 09 and 10), but it was not possible to detect if cracking was widespread. At first, some blocks appeared not to have been

Figure 9 - Cracks on the top side of the blocks, descending to the sides

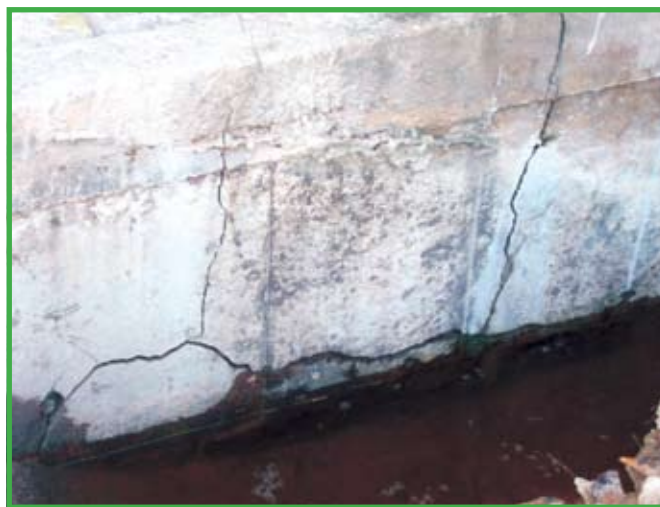
Figure 10 - Detail of the cracks on the side of the block

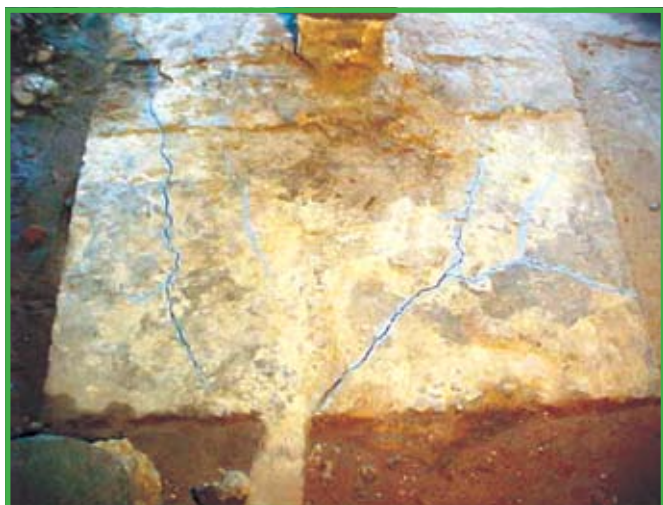
Figure 11 - Detail of a block in which the tie restricted the expansion towards it, thus inducing wedge-shaped cracking

The sixth case, a rather serious one, was detected in a 21-year old building in the Boa Viagem neighborhood. All the blocks featured cracking, with some appearing visually very critical (Figures 11, 12, 13 and 14).

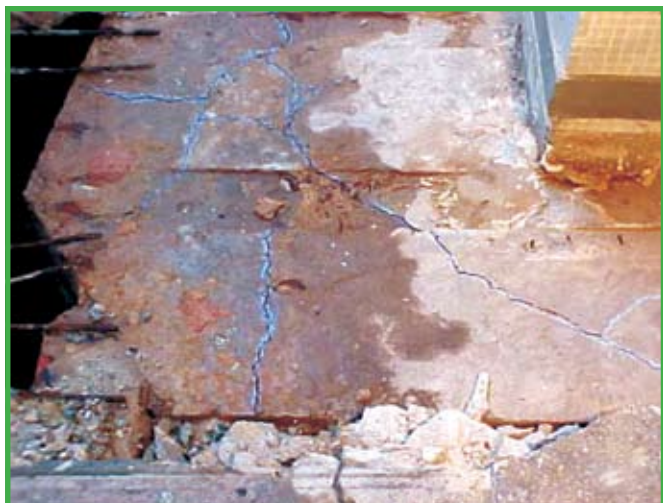
Figure 12 - Random cracking on the top side of the block

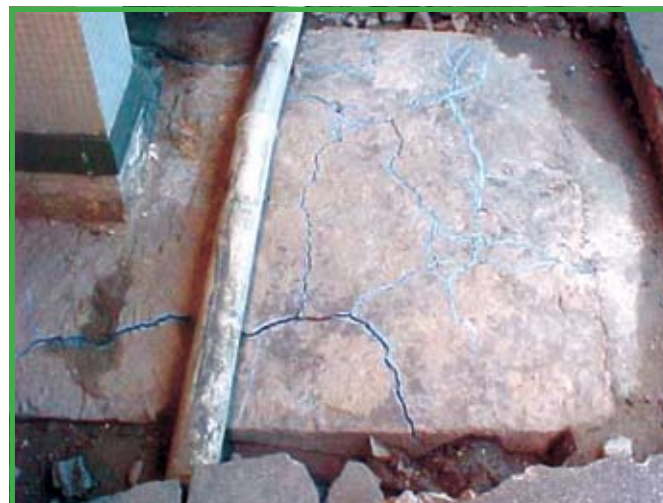
Figure 13 - Random cracking on the top side of the block

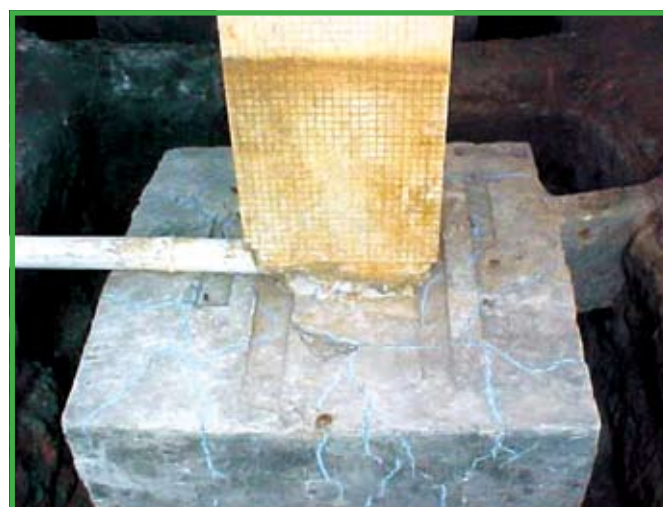
Figure 14 - Random cracking on the top side of the block, descending along the vertical side

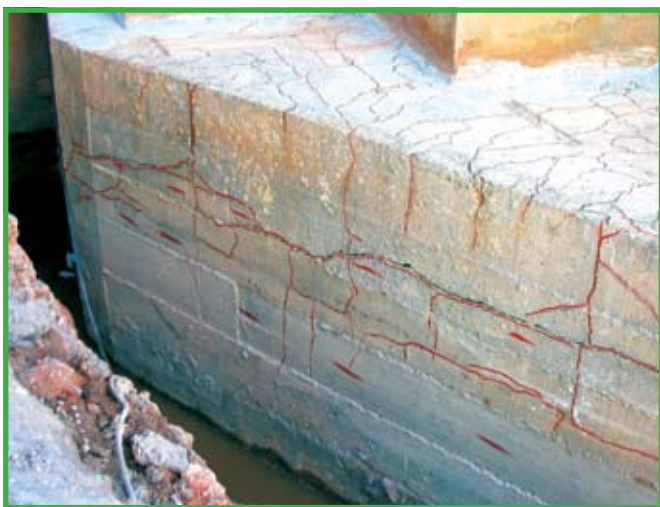
Figure 15 - Intense cracking on one of the blocks, with greater occurrence on the top and sides, down a certain length along the side, where the reinforcement is less intense

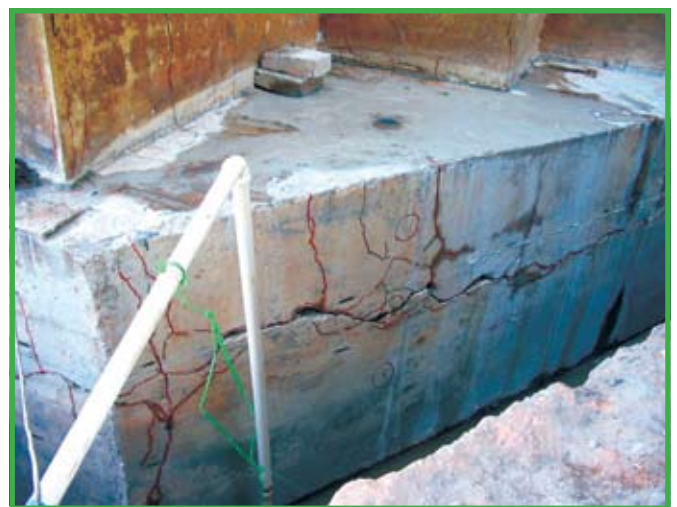
Figure 16 - Horizontal crack with a wide opening on the side of one of the blocks. In that area, there is a 35 cm zone without vertical reinforcement, which could restrict the expansion in that direction

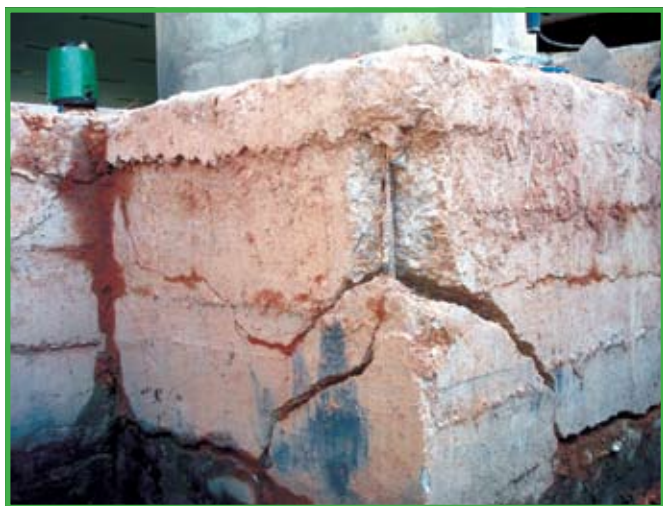
Figure 17 - Detail of a crack on one of the corners of the block

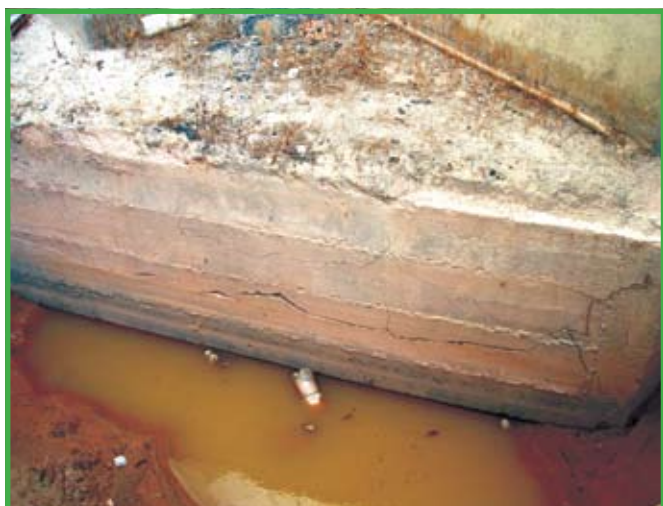
Figure 18 - Side view of one of the cracked blocks

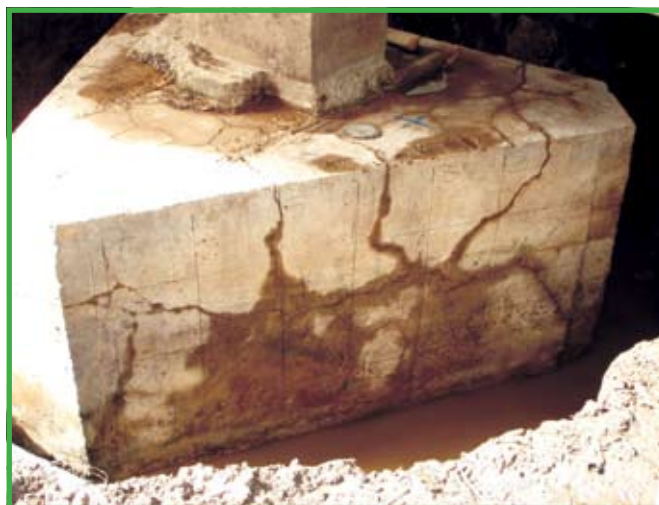
During inspection, after the demolition of the floor slab of the garage level (partly underground), a situation of varied cracking intensity was observed on the foundation blocks (figure 19). It must be noted that during the 10 years in which construction was paralyzed, the floor that was partly under ground was covered by a sheet of water a great deal of the time, due to poor drainage of the rain water and the high level of the local water table in the rainy season.

Figure 19 - View of a cracked triangular block

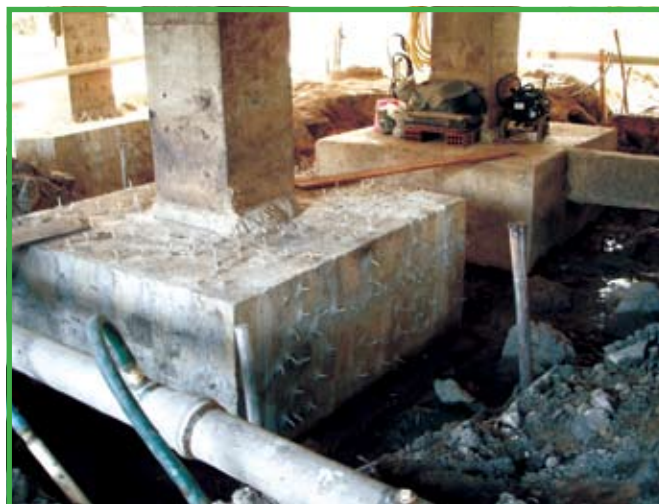
Figure 20 - View of two rectangular blocks, the first being intensely cracked, while the second (behind) has no cracking symptoms
