Durable Continuously Reinforced Concrete Pavements through Active Crack Control

Lambert Houben, Dongya Ren, Anne Beeldens, Luc Rens

3rd International Conference on Best Practices for Concrete Pavements, Bonito, Brasil, October 28-30, 2015

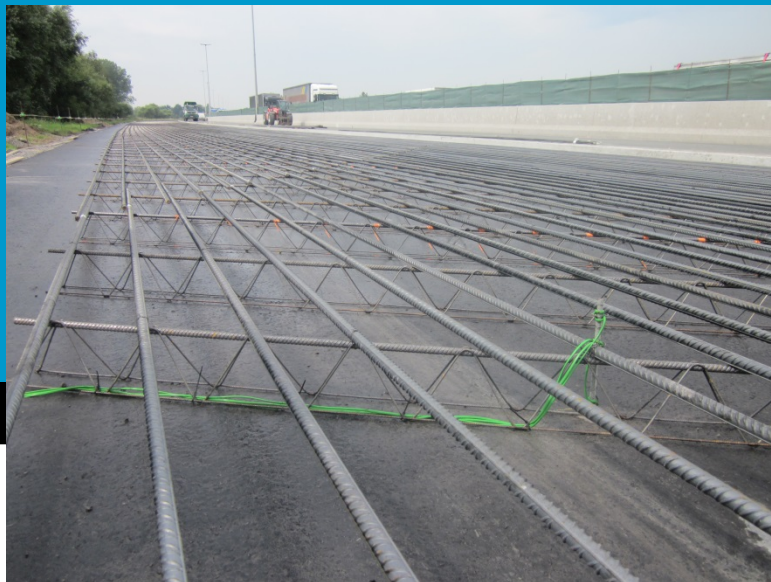
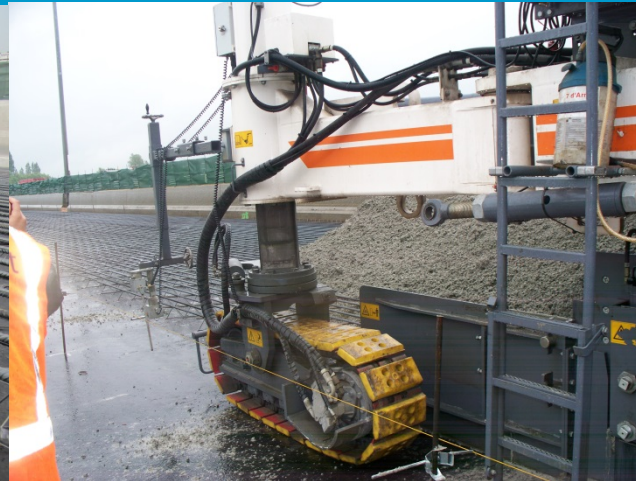
Longitudinal reinforcement (e.g. \varnothing 20 mm @ 180 mm)

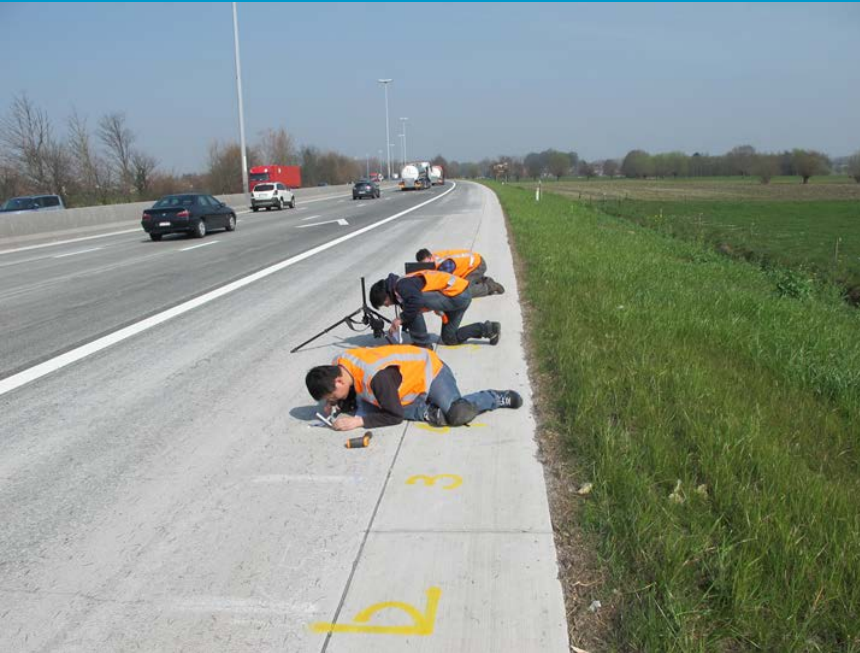
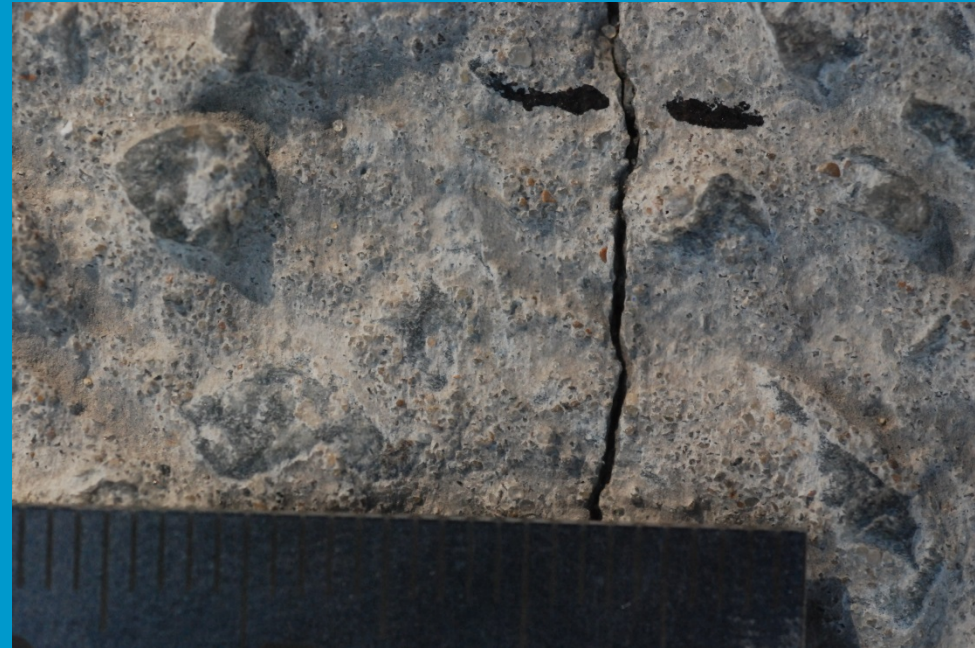
Crack width measurements at pavement surface

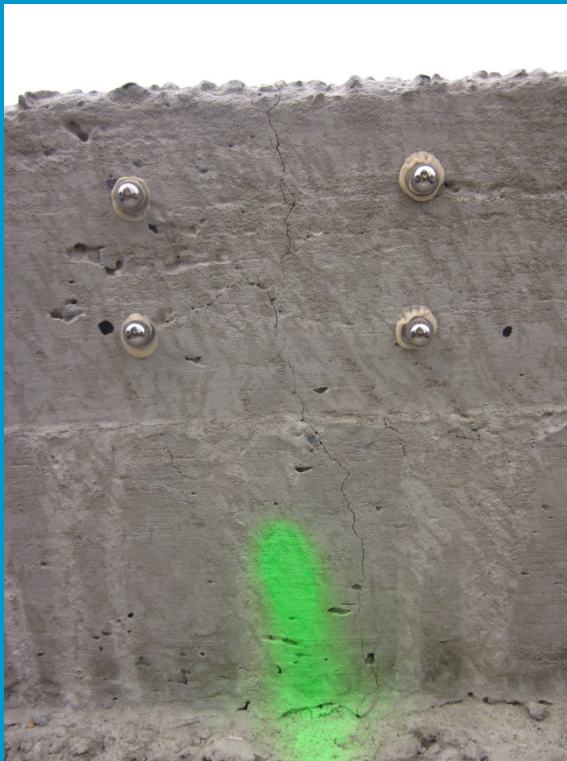
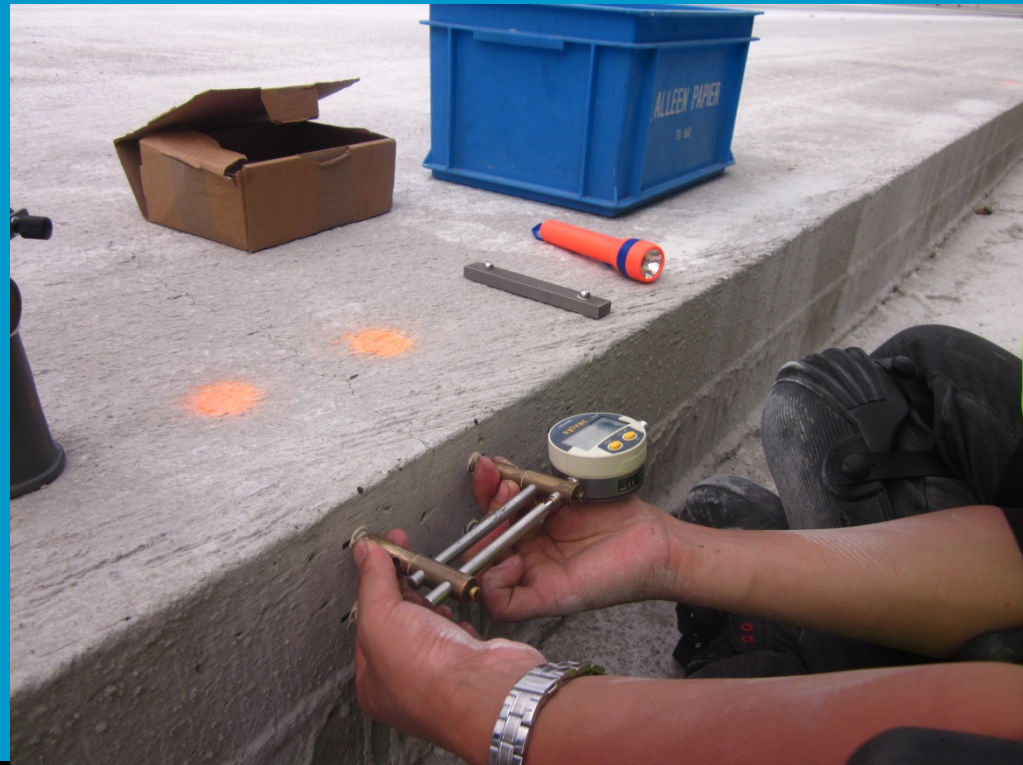
Change of crack width measurements ad pavement edge
(LVDT measurements on glued studs across crack)

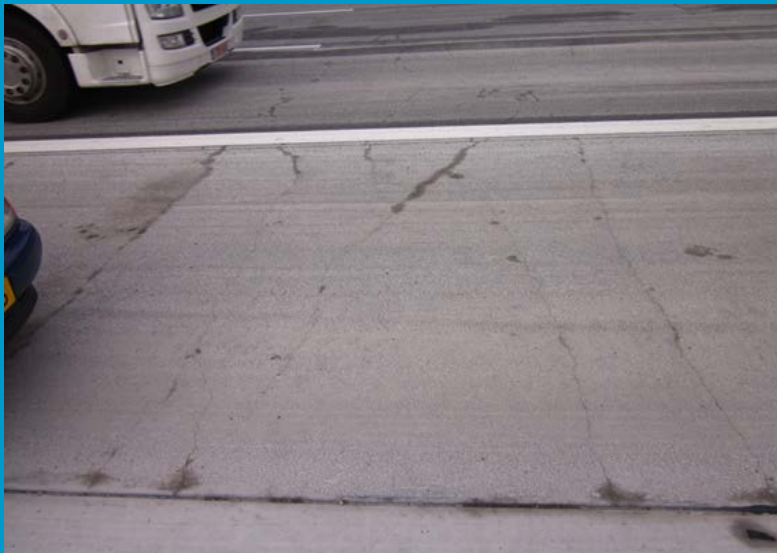
Typical cracks

Y-cracks

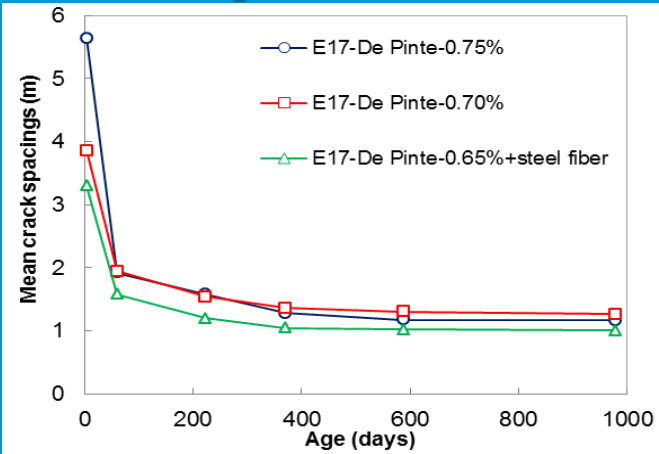
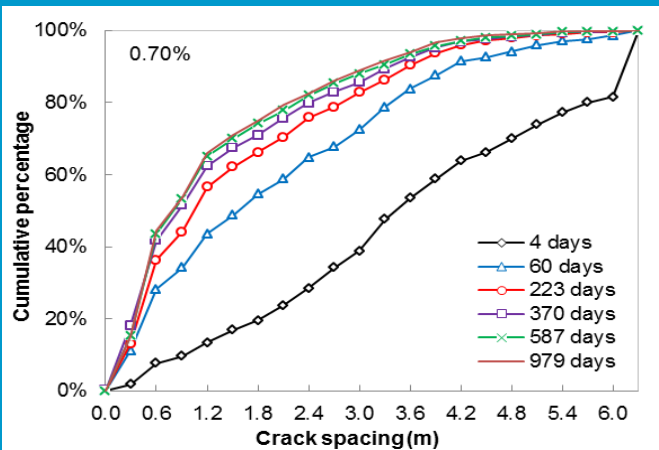
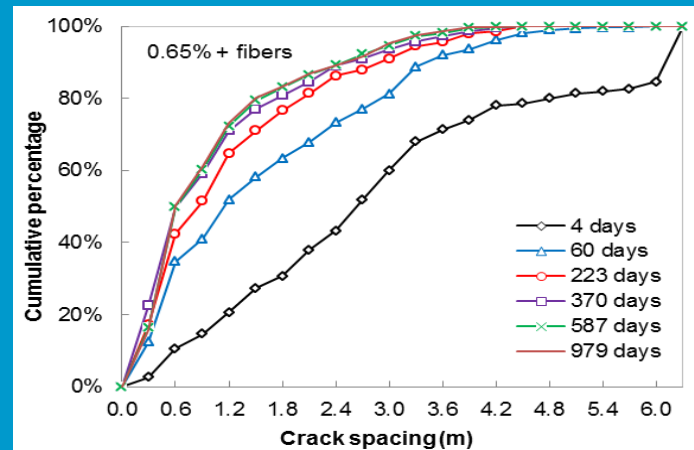
Development of crack spacing

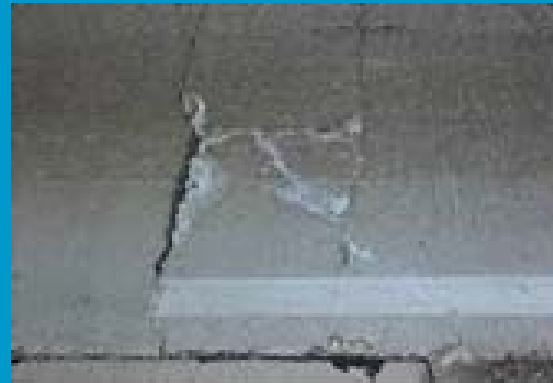
Risk of closely spaced cracks: punchouts

Early 2015 1 punchout observed in wheel track of test section 3 (0.65% + 20 kg/m³ steel fibers)

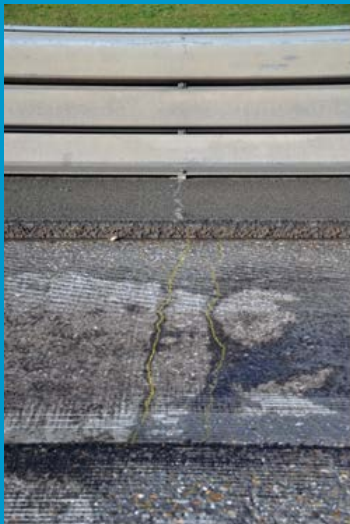
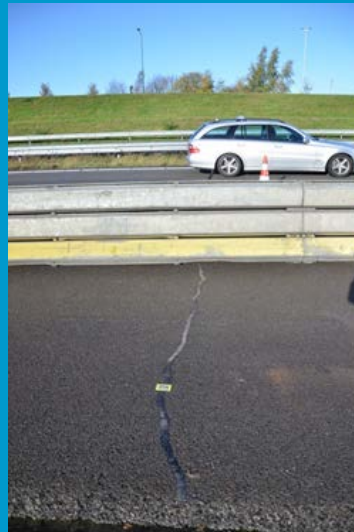
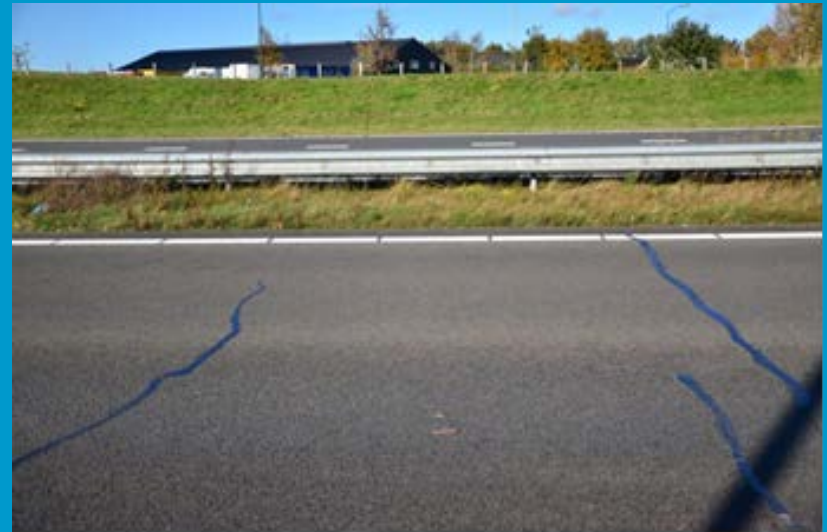
70 mm twinlayer PA wearing course on CRCP

8 years after construction: reflective cracking

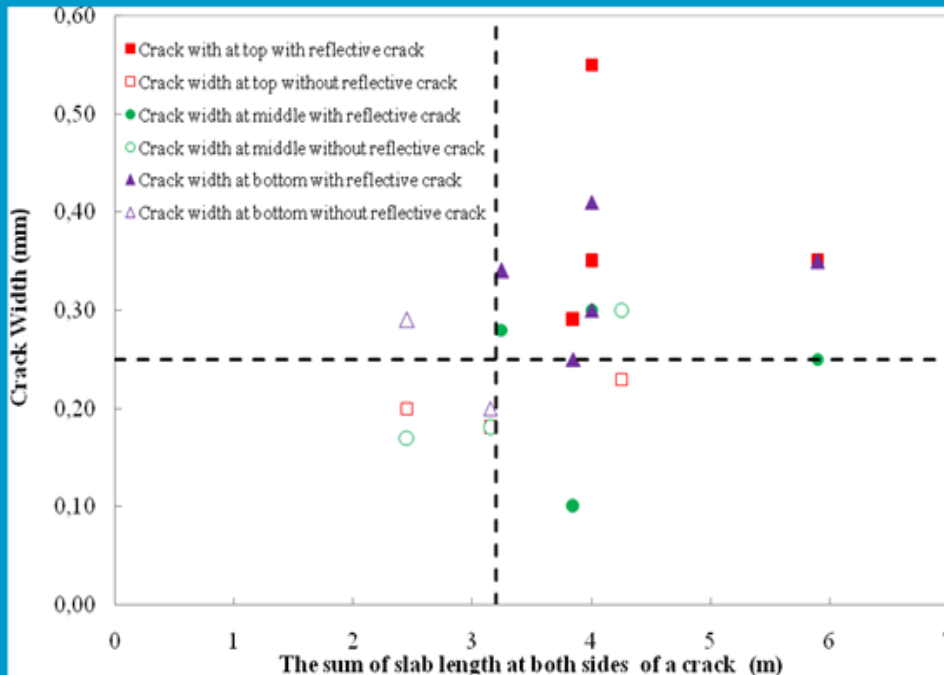
Cores taken on 9 cracks for crack width measurements

To prevent reflective cracks in this specific case:

- crack width < 0.25 mm
- sum of crack spacings < 3.2 m, i.e. crack spacings < 1.6 m

Mid 2014 (age 9 years) PA milled off and replaced by SAMI plus 70 mm twinlayer PA

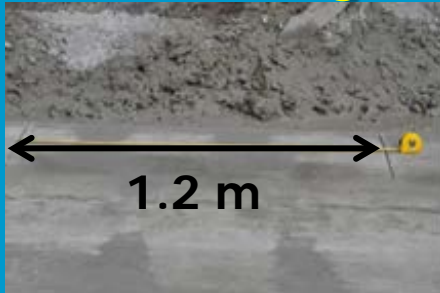
Geometry of notches

spacing

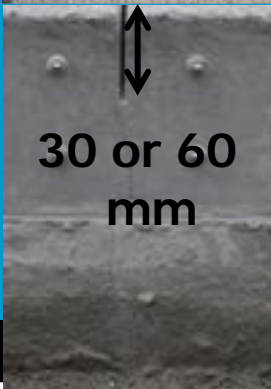
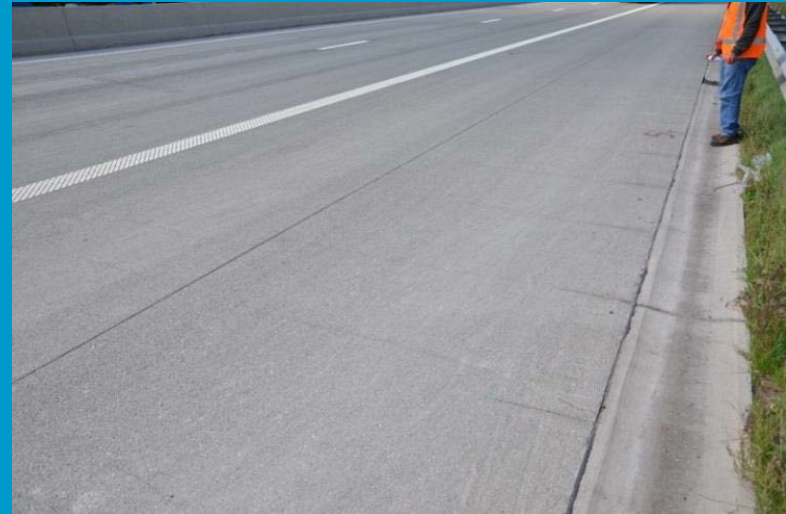
depth

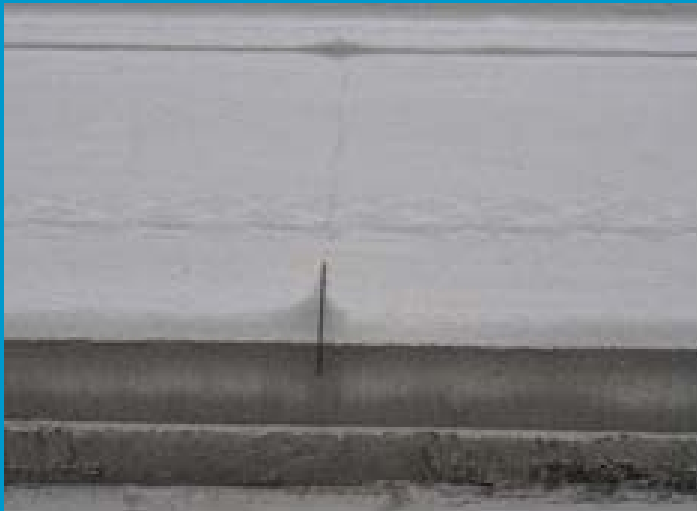
Straight cracks

crack at notch

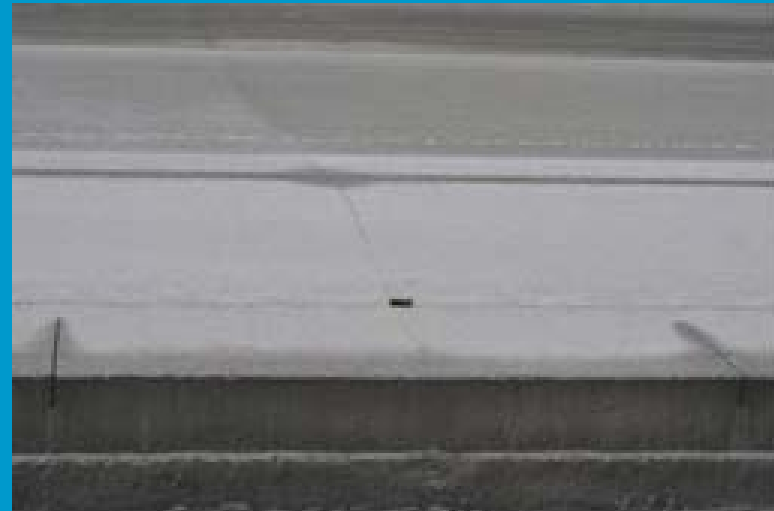
crack in between 2 notches

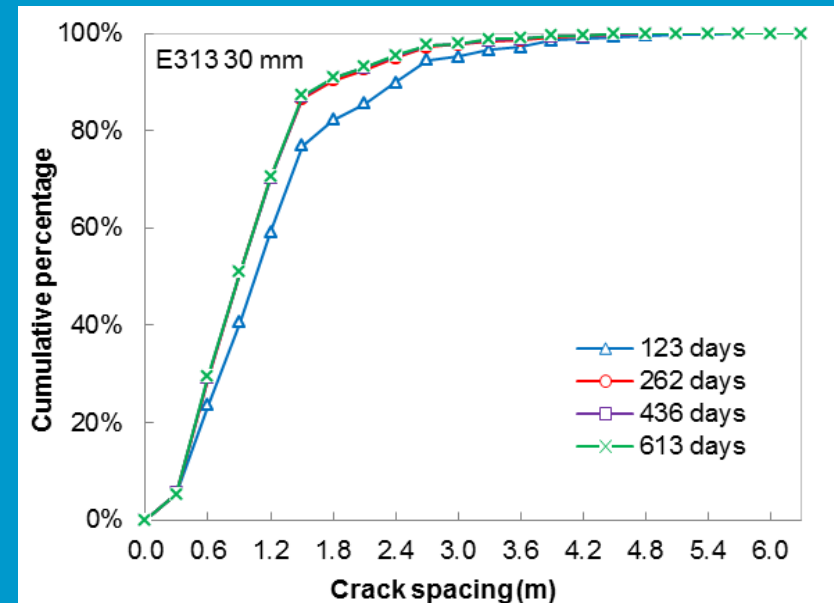
Crack spacing frequency distributions

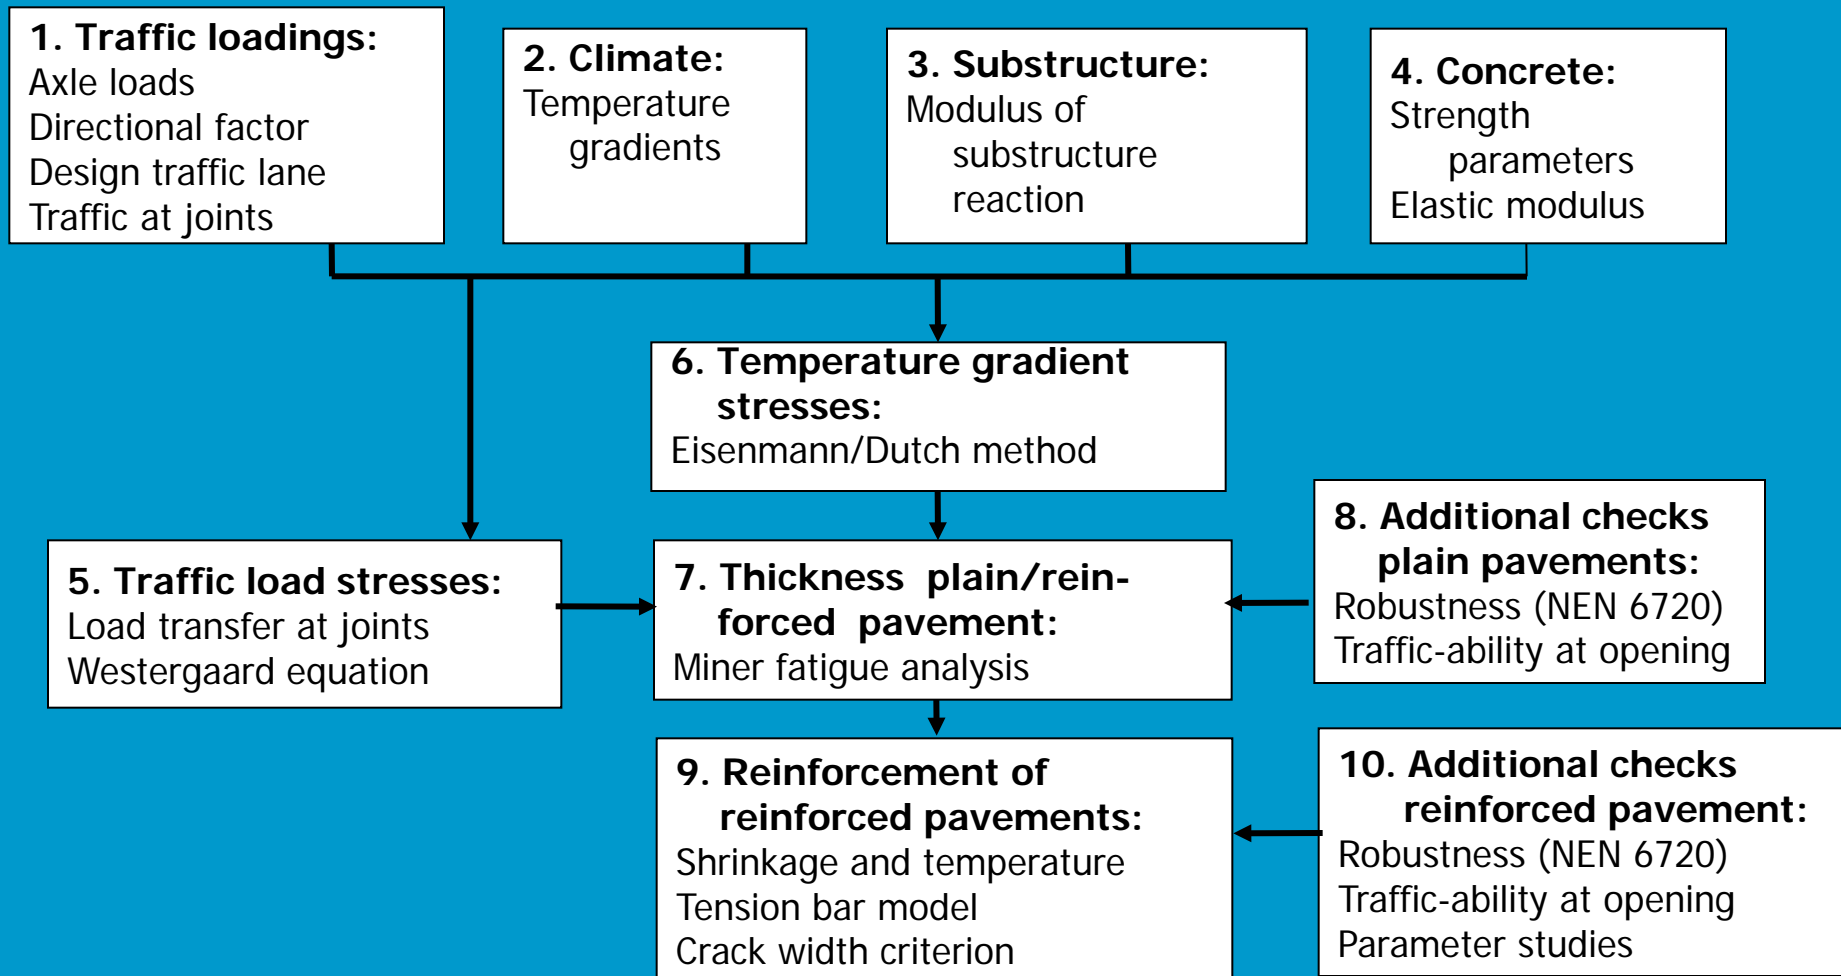
Analytical design method: VENCON2.0 (NL)

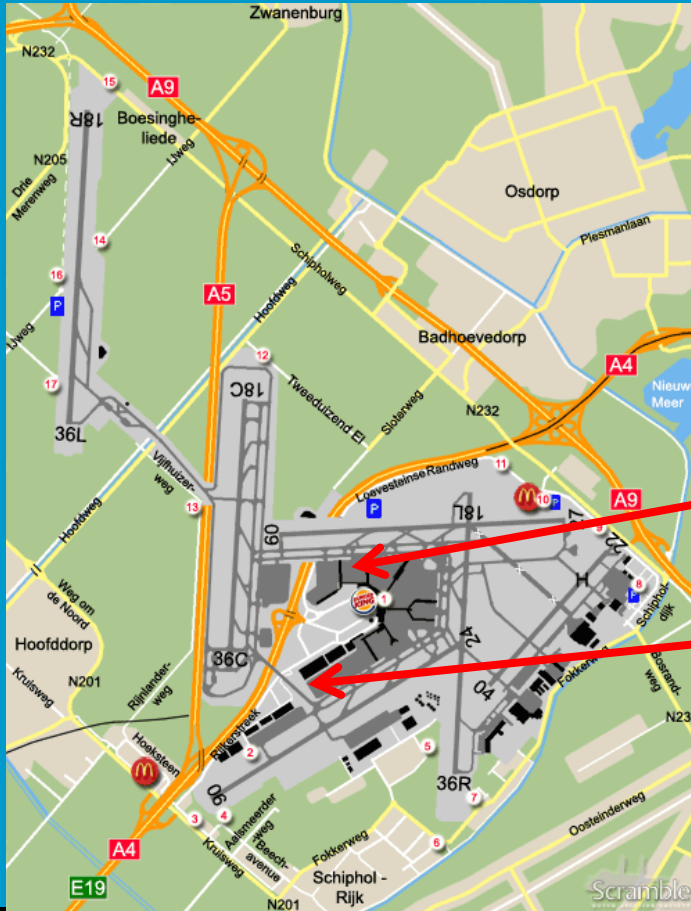
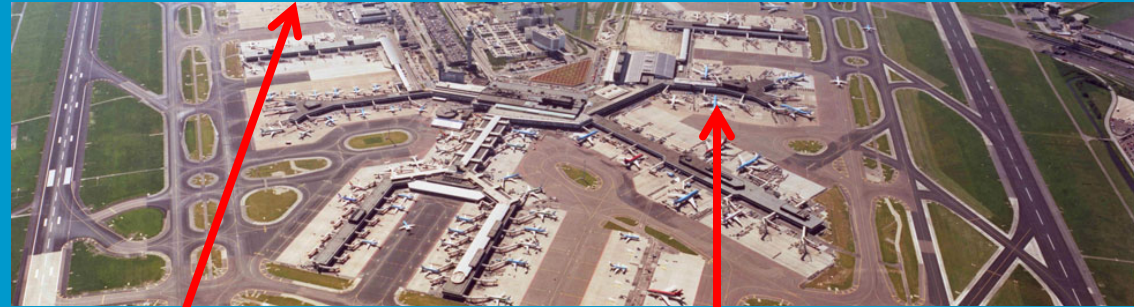
**JPCP (new),
up to 420
mm thick**

Prestressed (old), 180 mm thick

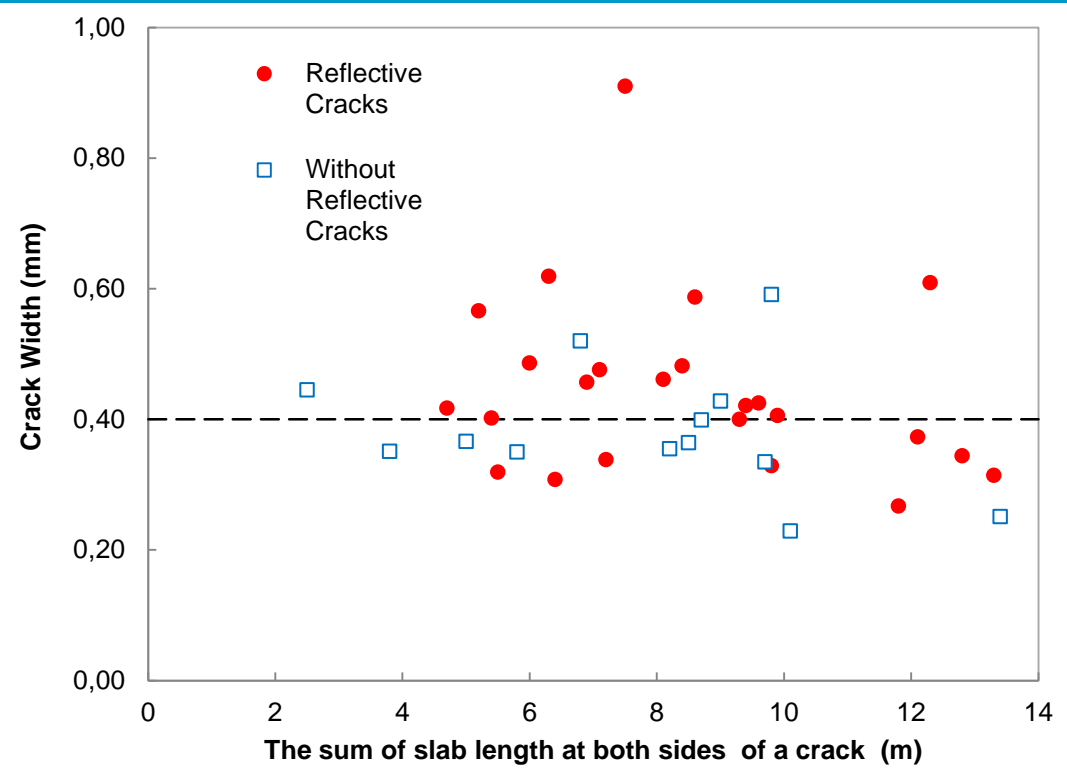
Crack width characteristics at pavement surface (37 cracks)

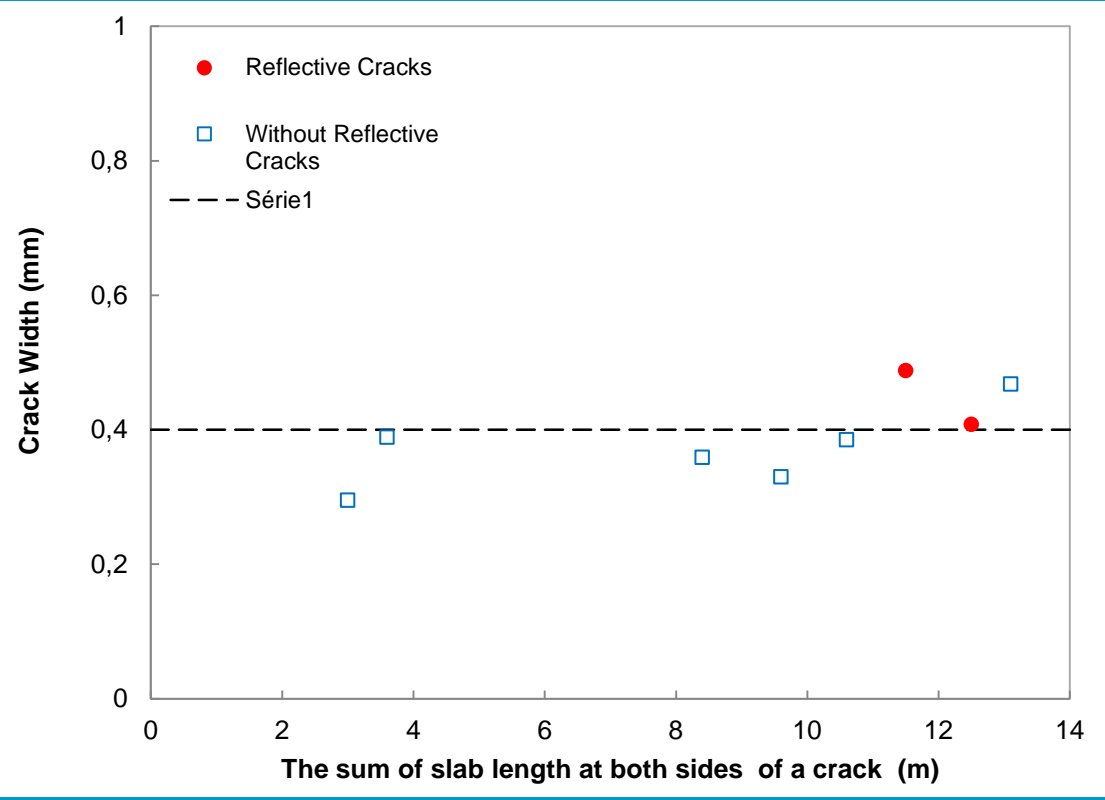
Cores taken on 12 cracks for crack width measurements

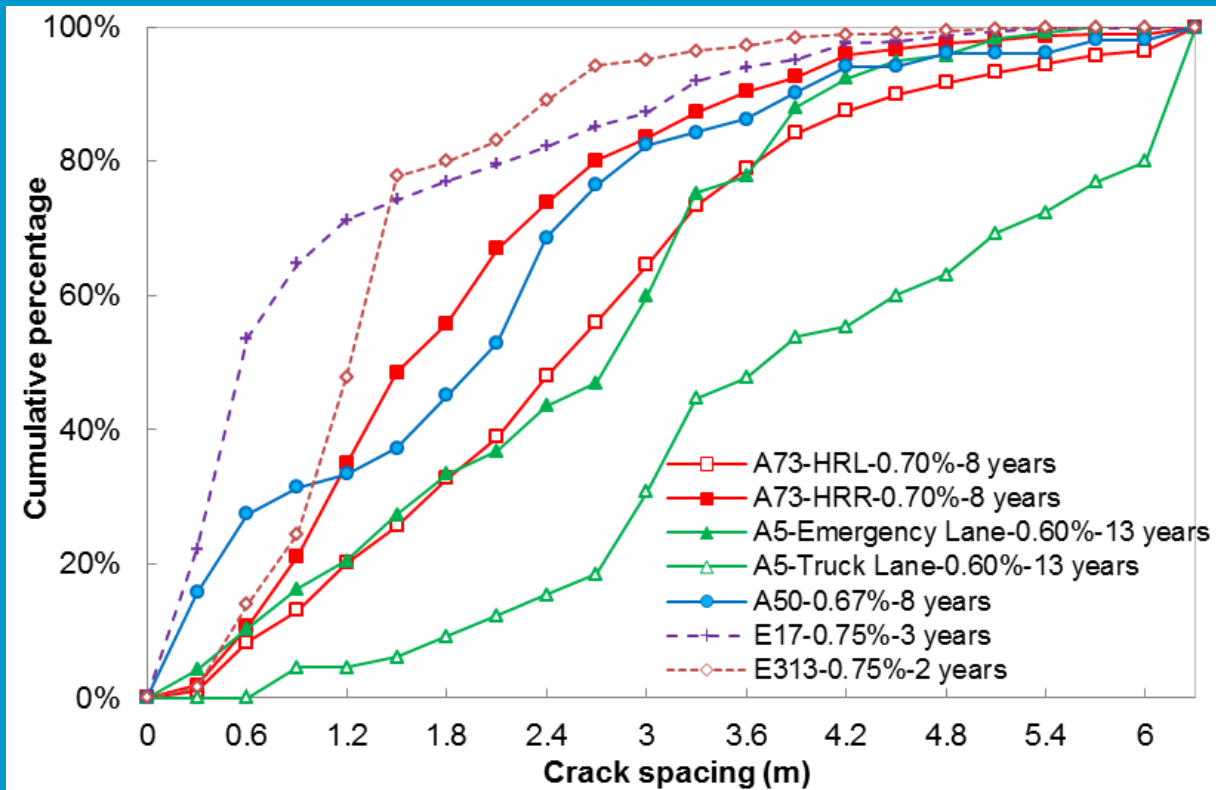
Comparison of crack spacing frequency distributions: huge differences!
