Mitigation of the Effect of Alkali-Silica Reaction in Concrete Structures: A Review

B. FOURNIER ^a
M.A. BÉRUBÉ ^b
M.D.A. THOMAS ^c
K.J. FOLLIARD ^d

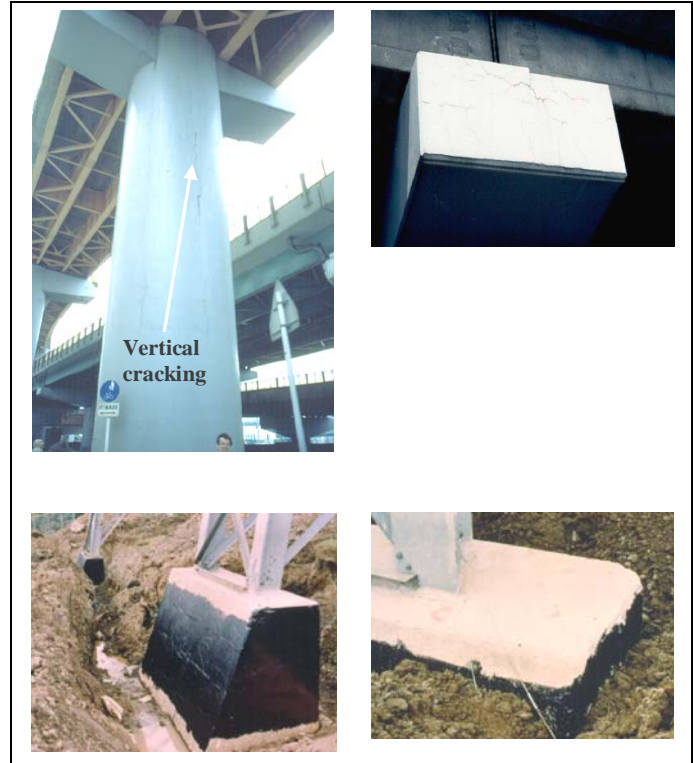
Figure 2 - (A). Reinforced concrete pier of the Hanshin expressway in Kobe (Japan) affected by ASR. Vertical cracks reappearing a few years after the treatment with various types of coating. **(B).** Beams were also repaired by using either polyurethane resins or epoxy resins; cracks also reappeared shortly after the treatment. **(C & D).** Massive electric tower foundations affected by ASR. Some of the foundations were treated by applying a bituminous coating on the buried surfaces and a flexible water-resistance polymer membrane on exposed concrete surfaces.

Putterill and Oberholster (1985) have found that some surface film coatings, such as polyurethane coatings and water repellent agents, e.g. water-based silicates, were ineffective in preventing long-term water penetration. Badly cracked concrete piers supporting the Hanshin Expressway in Japan were repaired at an age of 7 years by first filling the cracks with an epoxy resin injected under pressure and then either coating with an epoxy resin or impregnating with silane followed by a cosmetic coating of a polymer cement paste (Hobbs 1988) (Fig. 2A). This approach did not suppress the expansion of the piers since, after only a few years of further exposure, some crack widening had been observed (Fig. 2B). Ono (1989) also reported limited effectiveness of crack injection followed by surface coatings on concrete structures in Japan.

Impermeable surface coatings/membranes may represent an interesting approach to prevent further deterioration of concrete (e.g. due to frost action) when expansion due to ASR is terminated. Durand (2000) reported the results of monitoring ASR-affected concrete foundations of electric steel towers that had been subjected to various types of repairs, including epoxy injection, impermeable coating, strengthening and encapsulation. The data showed that the foundations to which a bituminous coating had been applied for the buried portions and the exposed parts coated with a flexible polymer membrane continued to expand at a significant rate after the repair work (Fig. 2C & 2D).

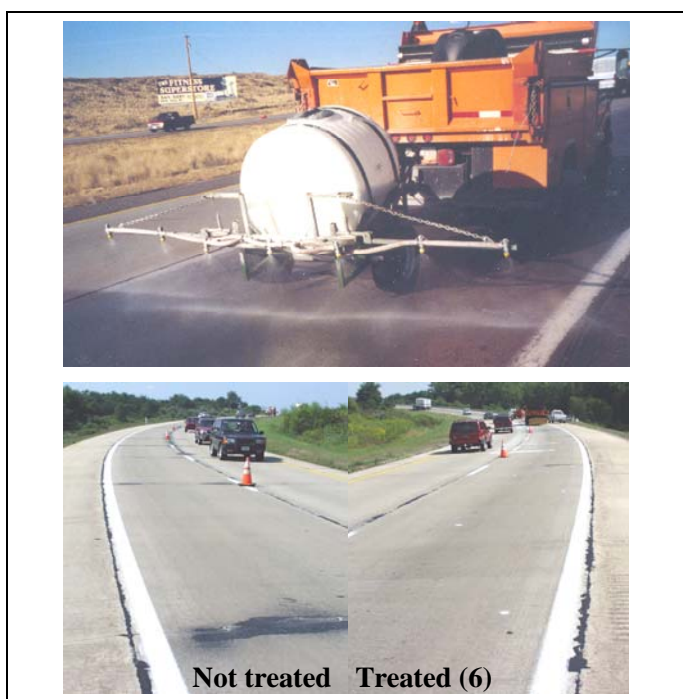
Figure 3 - (A). Topical application of lithium-based solutions at the surface of a pavement section affected by ASR (B). Condition of not-treated (control) and treated sections (after six topical treatments with lithium nitrate solution) of concrete pavement affected by ASR in Delaware (USA). Spalling of concrete at joints is more frequently observed in the untreated sections (Pictures A & B: courtesy of D.B. Stokes, FMC Corporation – Lithium Division, Charlotte, USA).

Topical application has been the most common method of applying lithium to ASR-affected concrete (primarily pavements and bridge decks) in recent years (Fig. 3A). It is quite clear from past topical applications of lithium that the lingering question is whether or not topical treatment of lithium leads to sufficient penetration to reduce ASR-induced damage. The potential for lithium ingress is significantly influenced by the extent of deterioration of the concrete at the time of treatment. Cracking will clearly facilitate ingress of the solution, but, if the deterioration of the concrete has proceeded to far, it may be too late to treat the affected concrete.

Stokes et al. (2003) described the treatment of State Route 1 in Delaware, USA. Approximately 6.4 km of 8-year-old, ASR-affected concrete pavement was treated with six applications of 30%-LiNO₃ at a rate of 0.24 L/m² over a period of three years (two treatments per annum). Control sections were left untreated at either end of the project. Four years after the first application, one of the control sections was showing severe deterioration in the form of excessive cracking and spalling at the longitudinal and transverse joints. Figure 3B shows photographs of the control and treated sections at this age, and it is evident that the treated sections exhibit less deterioration. One year later, this control section was rehabilitated by grinding the

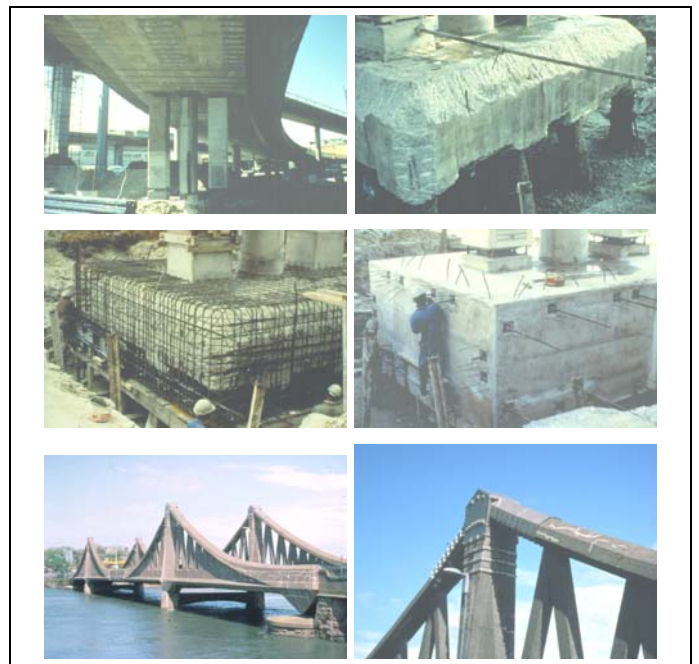
Figure 5 - (A-D). Highway structure affected by ASR in South Africa. (B). The cracked concrete in the pile caps was first removed. (C). Additional steel reinforcement was added around the pile cap. (D). External strengthening is provided by means of prestressed cables. (E). General view of Montrose bridge (Scotland) (F). The strengthening remedial work consisted in reinforcement by straps, plates and tensioned bolts to provide full containment for the top chord and tower top area. (A to D: courtesy of R.E. Oberholster, PPC Technical Services, Cleveland, South Africa) (E and F: courtesy of J.G.M. Wood, Structural Studies & Design Ltd., Chiddingfold, UK).

to 5D illustrate the repair of a highway structure affected by ASR in South Africa. Cracking due to ASR was observed in the pile caps supporting reinforced concrete columns. The cracked concrete was first removed (Fig. 5B), additional steel reinforcement was added around the pile cap (Fig. 5C) and external strengthening was provided by means of prestressed cables (Fig. 5D). Strengthening by introducing reinforcement with straps, steel plates and tensioning through bolts was also found to be effective in providing containment for the top chord and tower top area of the historical Montrose bridge in Scotland (Wood and Angus 1995) (Figs. 5E and 5F).

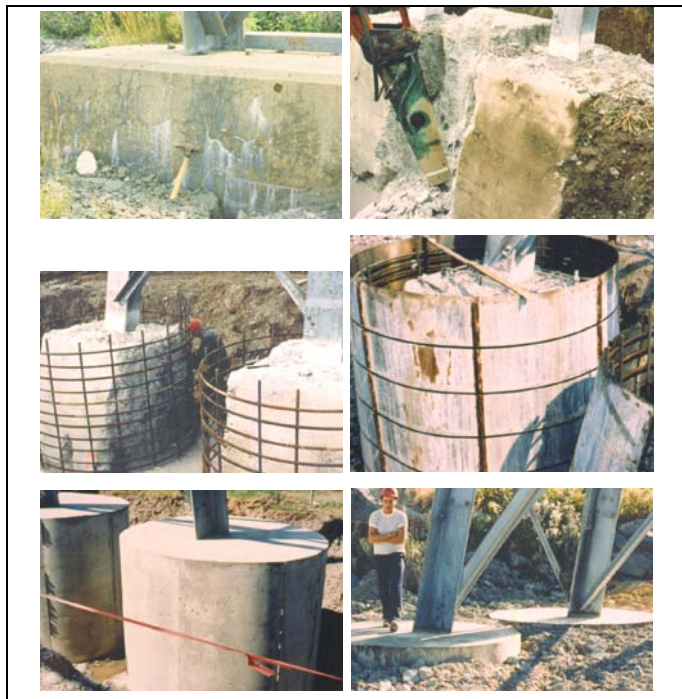
Figure 6 - (A to F). Repair of a group of electricity tower concrete foundation affected by ASR in Quebec City (Canada). (A). Map-cracking and gel exudation affecting a 29-year-old concrete foundation. (B). Splitting the foundations in two blocks. (C to F). Encapsulation with reinforcing steel and silica-fume concrete.

Methods to restrain expansion and movement in ASR-affected mass concrete foundations can include rock anchors and/or encapsulation. Bérubé et al. (1989) and Durand (2000) described the repair of a group of electricity tower concrete foundation affected by ASR in Quebec City (Canada). The foundations had suffered from significant swelling and cracking due to ASR (Fig. 6A). The repair program selected consisted in splitting the foundations in two blocks (Fig. 6B), followed by the encapsulation with reinforcing steel and silica-fume concrete (Figs. 6C to 6F). Durand (2000) showed that this type of treatment resulted in significant reduction in the expansion rate of the affected element. Care should be taken in designing the encapsulating element because, if sufficient reinforcement is not provided to control stresses due to AAR expansion,

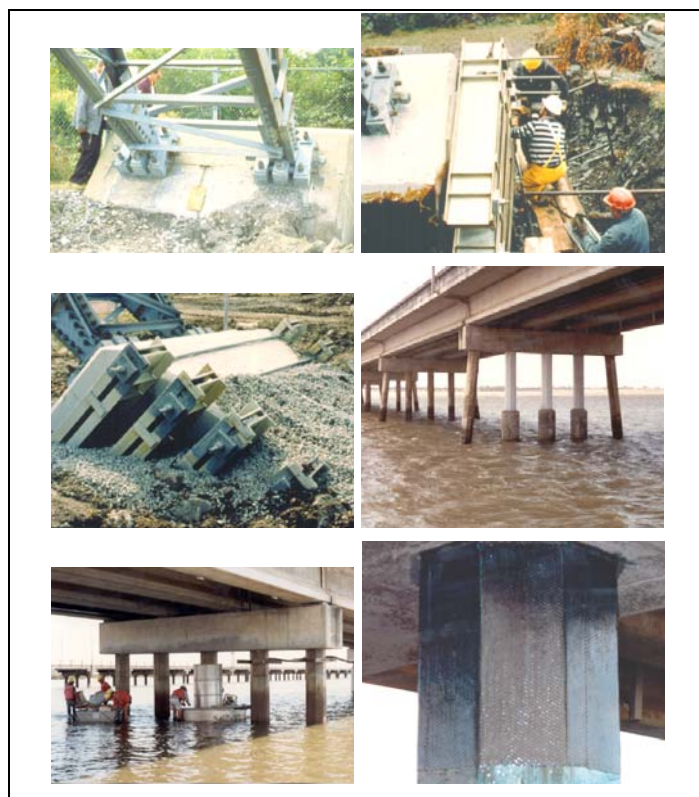
Figure 7 (A) - Concrete anchor block for electricity towers affected by ASR (B and C). External strengthening using steel frames, rods and plates. (D to F). Bridge structure affected by ASR in Australia. (D). Glass-fibre composite repair to 500 above high water level and concrete encasement to bed level. (E). View of cofferdam and split aluminium formwork. (F). Wrapping with two layers of carbon fibre composite materials. (Pictures D to F: courtesy of A. Carse, Queensland Transport, Brisbane, Australia).

the only beneficial effect of encapsulation may be to limit the ingress of moisture (CSA 2000). In the case of the concrete anchor block for the above electricity towers (Fig. 7A), the repair approach selected was to apply a bituminous coating on the buried surfaces and a flexible water-resistance polymer membrane on the exposed concrete surfaces. External strengthening through the use of steel frames, rods and plates was then implemented (Figs. 7B and 7C) (Bérubé et al. 1989; Durand 2000).

Strapping or encapsulation of AAR-affected reinforced concrete columns by or with composite materials may be an interesting solution providing sufficient structural strengthening is assured. Carse (1996) described the repair program of a bridge structure affected by ASR in Australia. Vertical cracking has been observed in the pre-stressed octagonal piles supporting the structure about 13 years after commissioning. The repair strategy consisted in monitoring progress of ASR expansion and then repair the piles in which ASR had nearly exhausted itself. Glass-fibre composite repair to 500 above high water level and concrete encasement to bed level was performed (Figs. 7C to 7E). As an alternate method to the glass-fibre composite, wrapping was also carried out with two layers of carbon fibre composite materials (Carse 1996) (Fig. 9F).
