AAR in Brazilian Bridge Foundations Tests and Rehabilitation Procedures

The Paulo Guerra Bridge (PGB) on Recife, Brazil was constructed during 1977. 25 years later, it shows evident deterioration signs on the deck, superstructure and sub-structure, which are caused not only by the surrounding atmosphere but also by wrong materials selection and poor supervision during construction. Damages on deck and super-structure have been inspected and the results published elsewhere [1]. This paper will deal with the inspection of the foundation blocks that are part of the sub-structure.

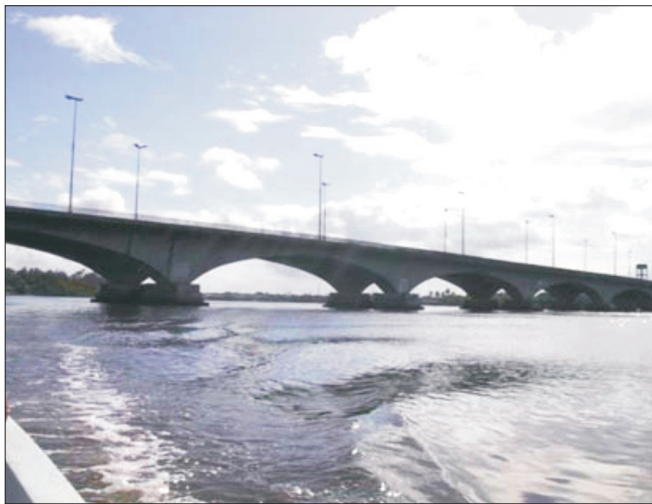
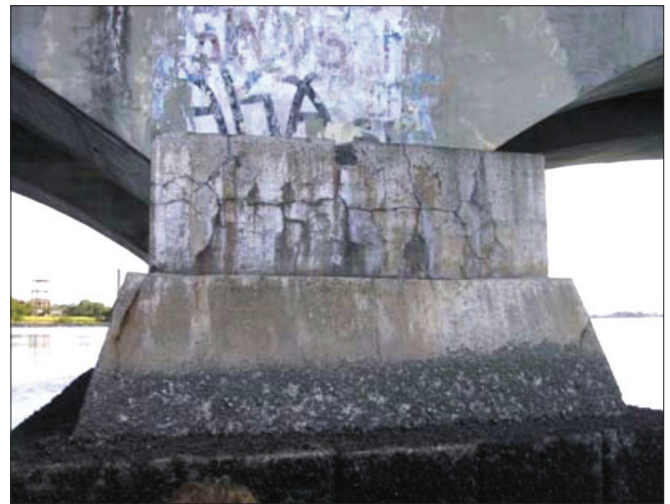
Figure 1 – PGB view, emphasizing some deteriorated parts

A general view of the PGB can be seen on Fig. 1. It is surrounded by a marine atmosphere according to the

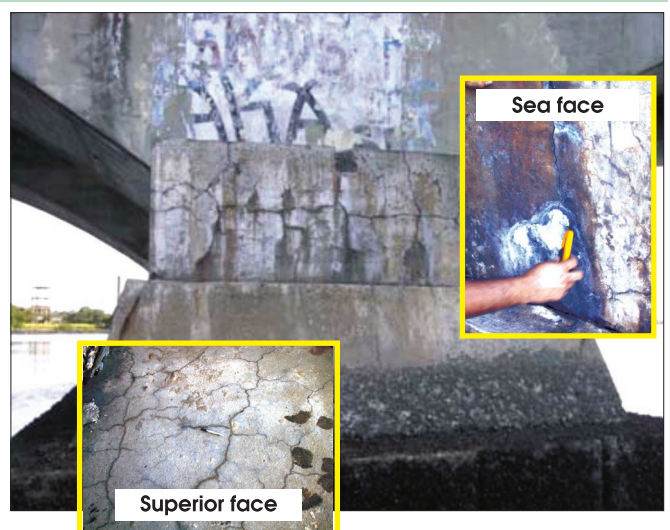
The foundation blocks were constructed following an innovative technique which included the positioning of pre-cast reinforced concrete boxes on the piles, which served as permanent forms for the concrete blocks, as illustrated on Fig. 2. After 25 years of service, the concrete blocks and boxes showed evident deterioration through durability cracks and corrosion stains. The objective of this paper is to show that mechanical techniques together with others different than ASTM C 1260 and C 289 can help to verify the AAR. Then, rehabilitation can be proposed based on durability criteria.

Figure 2 – Schematic details of one representative concrete foundation block
